Manhole Inspection Summary

Manhole # S33I__020MH

Insp Date: **3/26/08 10:16 AM**

Location Address: **100 hanover st**

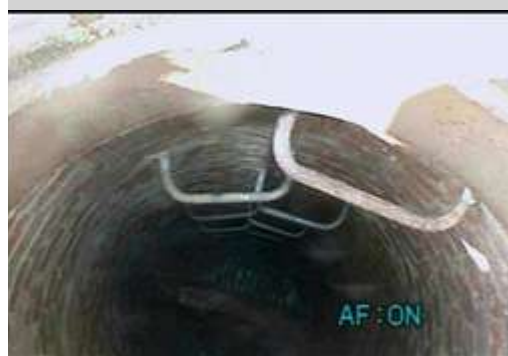
Defect 1

Count: **10** Missing: **0** ☒ **Corroded**

corroded steps

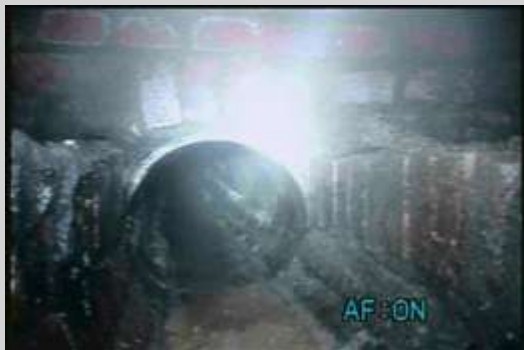
12 O'Clock Outflow

10 in. Circular Gravity Sewer
Pipe Out @ 12 O'Clock

Pipe Material: **Clay** ☐ Pipe Lined

Invert Depth: **15.38** (ft.) Flow Characteristics: **Fast**

Deposits: ☒ None ☐ Mud ☐ Sludge ☐ **Debris** ☐ Grease

Infiltration: **None** Pipe Seal Cond: **Unknown**

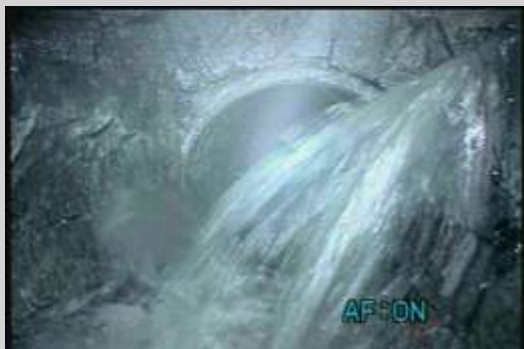
6 O'Clock Inflow

10 in. Circular Gravity Sewer
Pipe In @ 6 O'Clock

Pipe Material: **Clay** ☐ Pipe Lined

Invert Depth: **15.33** (ft.) Flow Characteristics: **Fast**

Deposits: ☒ None ☐ Mud ☐ Sludge ☐ **Debris** ☐ Grease

Infiltration: **None** Pipe Seal Cond: **Unknown**

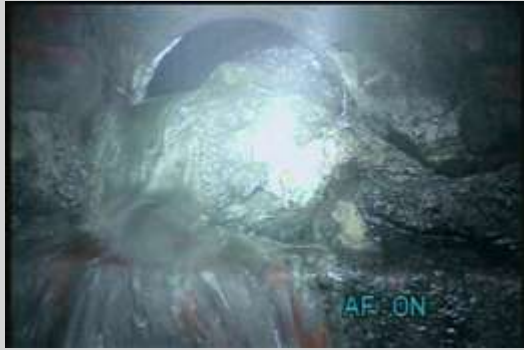
8 O'Clock Inflow

10 in. Circular Gravity Sewer
Pipe In @ 8 O'Clock

Pipe Material: **Clay** ☐ Pipe Lined

Invert Depth: **14.63** (ft.) Flow Characteristics: **Turbulent**

Deposits: ☐ None ☐ Mud ☐ Sludge ☒ **Debris** ☐ Grease

Silt Depth: **7** (in.) Deposits Extent: **Heavy**

Infiltration: **None** Pipe Seal Cond: **Unknown**
